2018 Rehabilitation vs Replacement Study

**Main Street Bridge Over Roanoke River
& NS Railway (Wasena Bridge)**

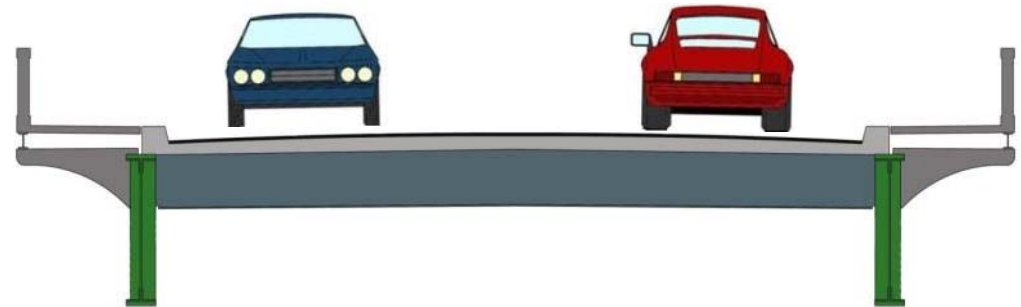
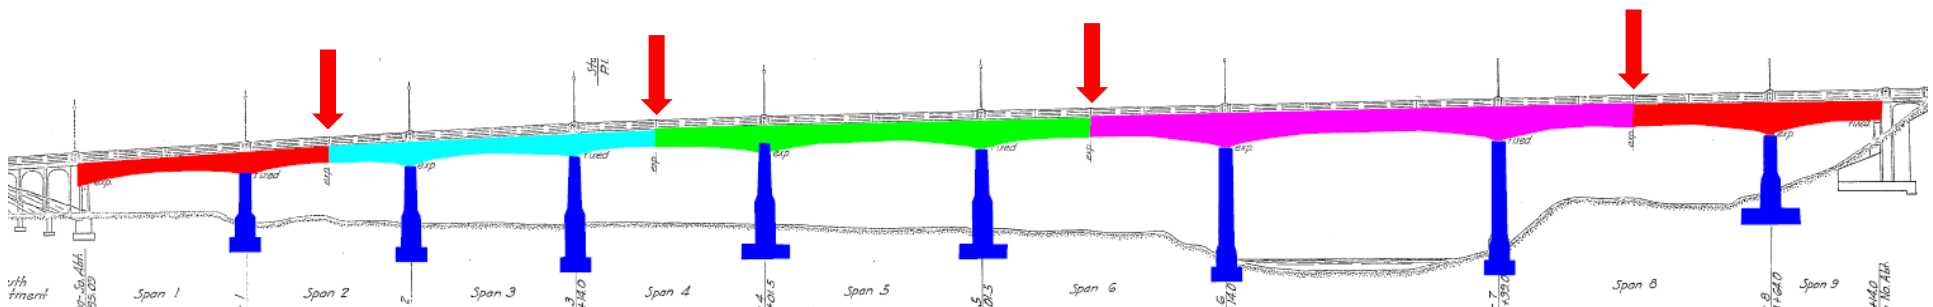
Existing Wasena Bridge

- Built in 1939
- Two girder system
- Fracture critical structure
- Two column piers
- Hinge joints within the spans

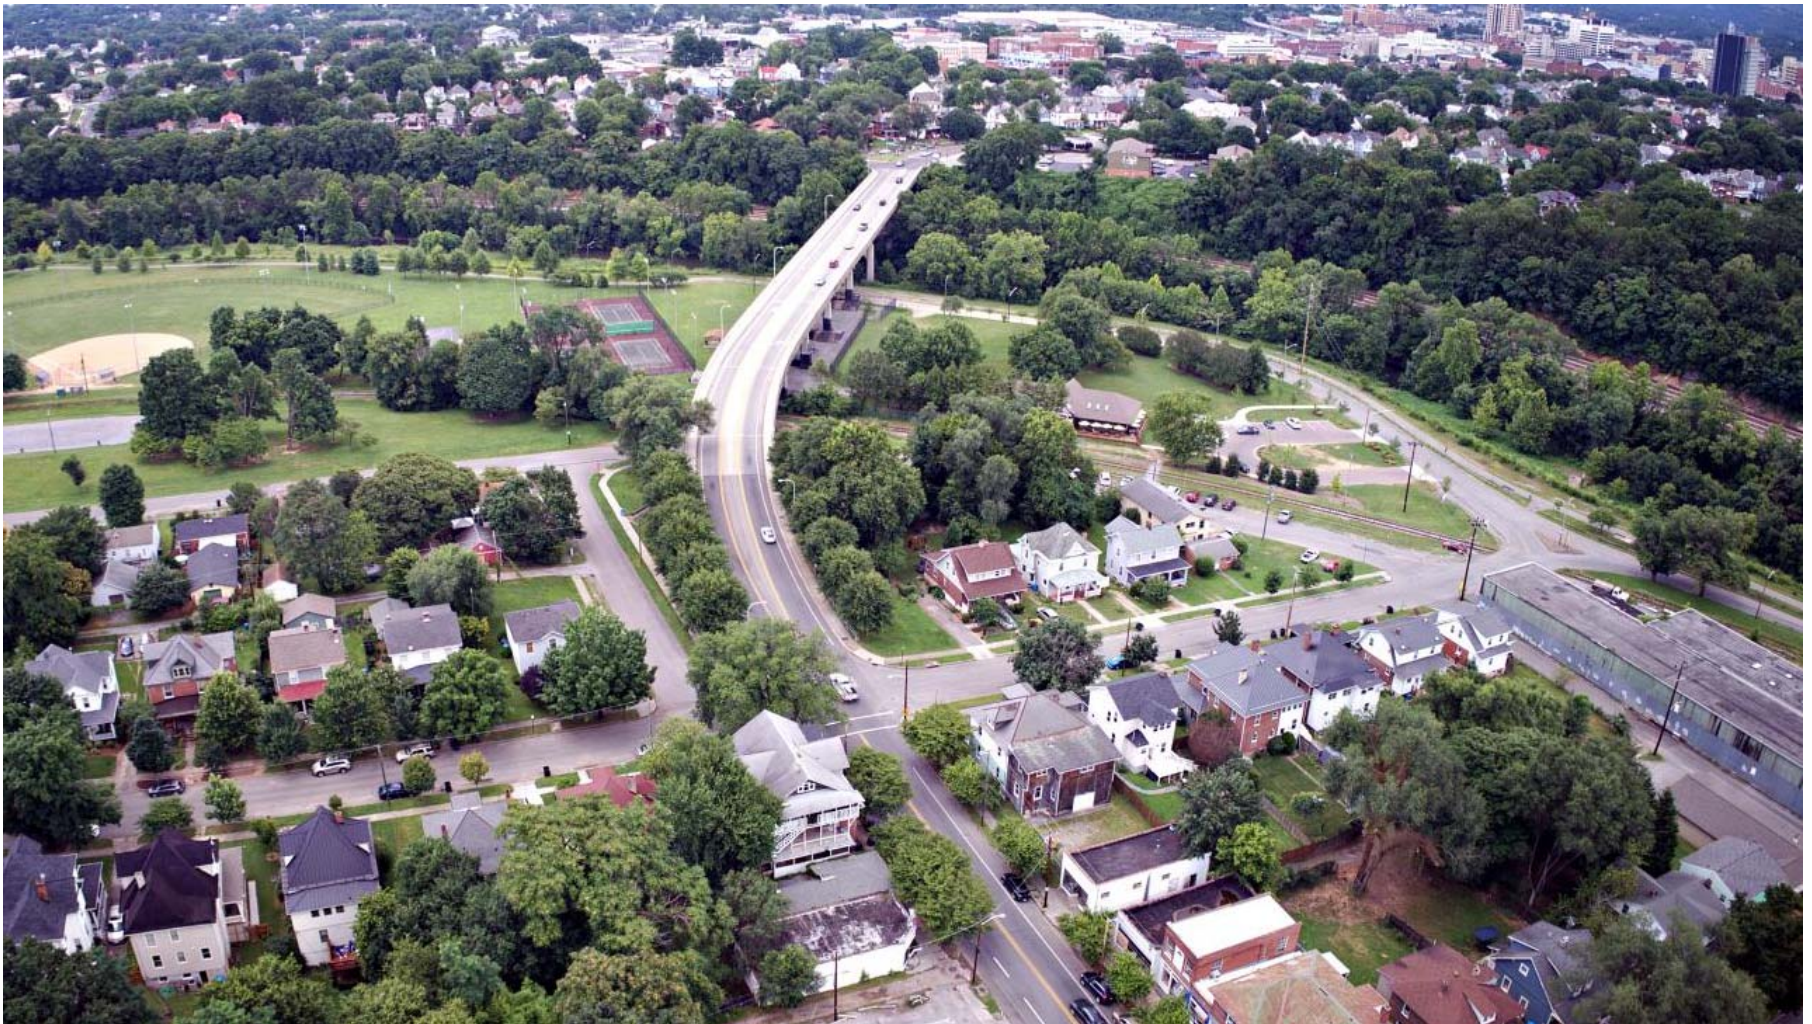
- Strategy: Build on new alignment

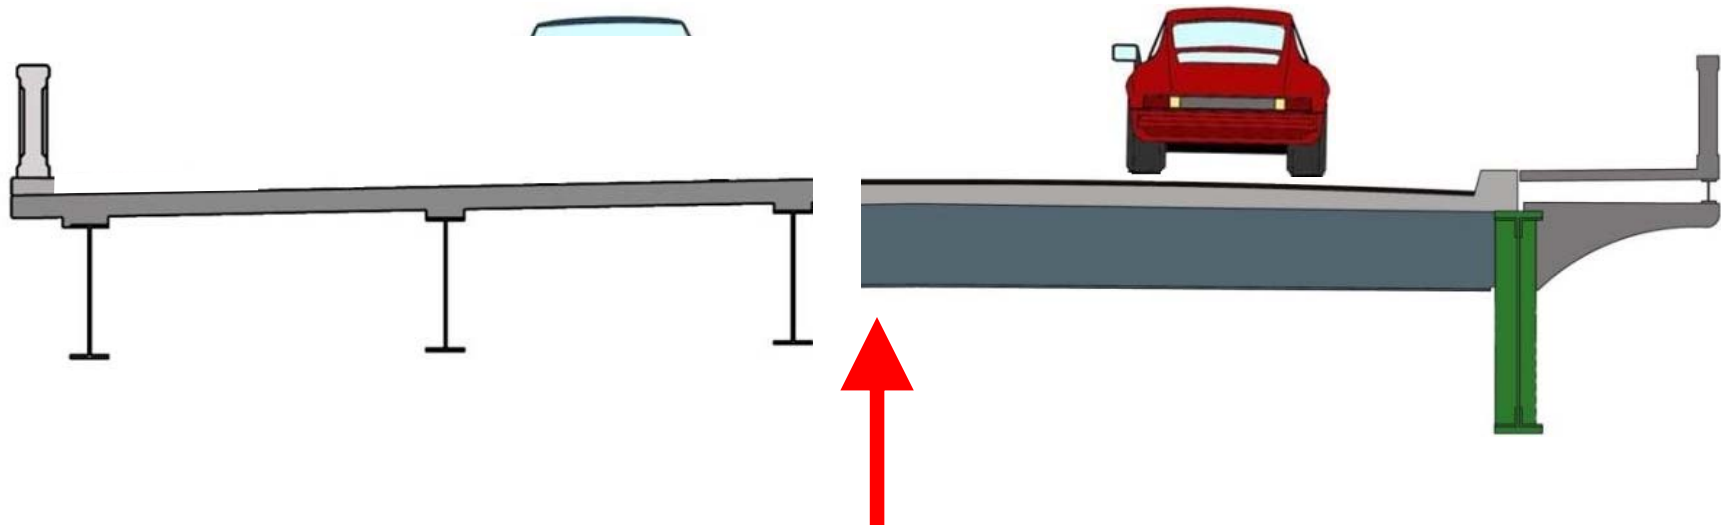
- Strategy: Build in two stages

- Long span lengths
- Crossing over Railroad
- Increased Cost

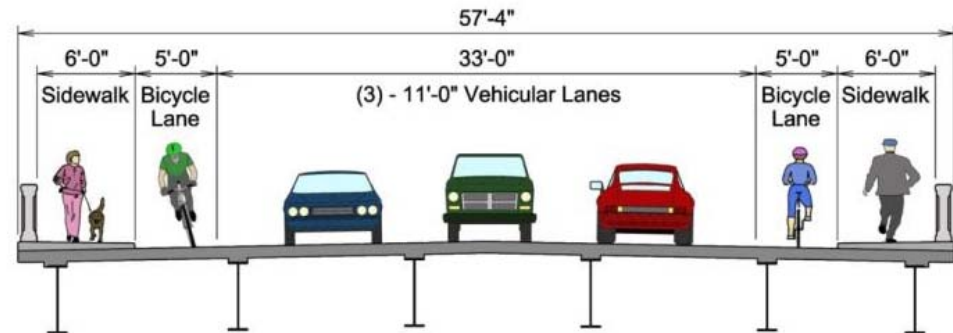
- Two column piers
- Individual footings
- Web wall
